# **Structural Inspection of the Riverside Dam**

## **Inspection Report – FINAL**

Project #TPB175082, The Corporation of the City of Cambridge

8/23/2018

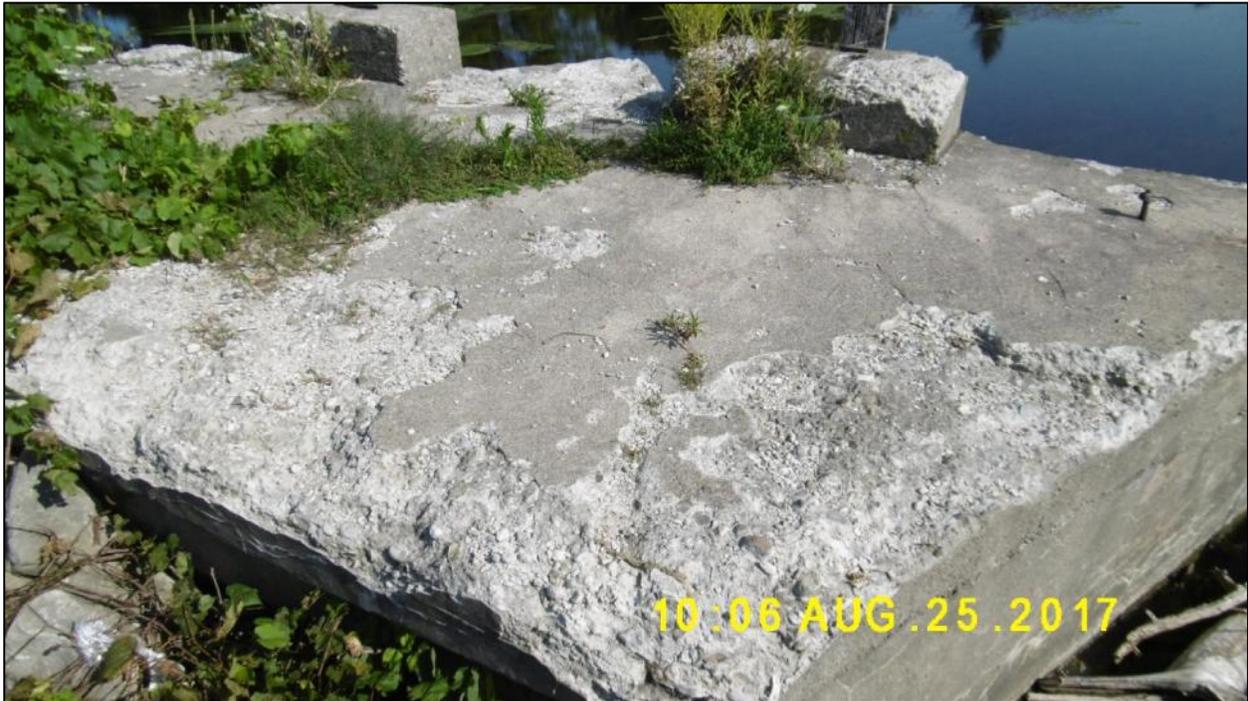
The south stop log structure is generally in poor condition, with cracks, spalling and disintegration observed on the top face of the structure. A wide horizontal crack was visible in the wall around the majority of the structure. Debris, especially trees and vegetation, has built up upstream of the stop log structure. To prevent collapse or sliding of the south stop log structure, rip rap was placed directly downstream of the structure and used to block the raceways. As a result, no water flows through the structure and it no longer helps to control of flow of water over the dam. The northern wingwall was found to have a medium to wide longitudinal crack along the length of the wall. The underwater investigation found that the concrete relating to the stop log structure was in fair condition with light to medium scaling.

*Photo 13 – Top of South Stop Log Structure*

3. **The debris buildup throughout the dam should be removed as soon as possible. This includes the buildup around the north and south stop log structures, and the scattered debris jammed on the spillway.**

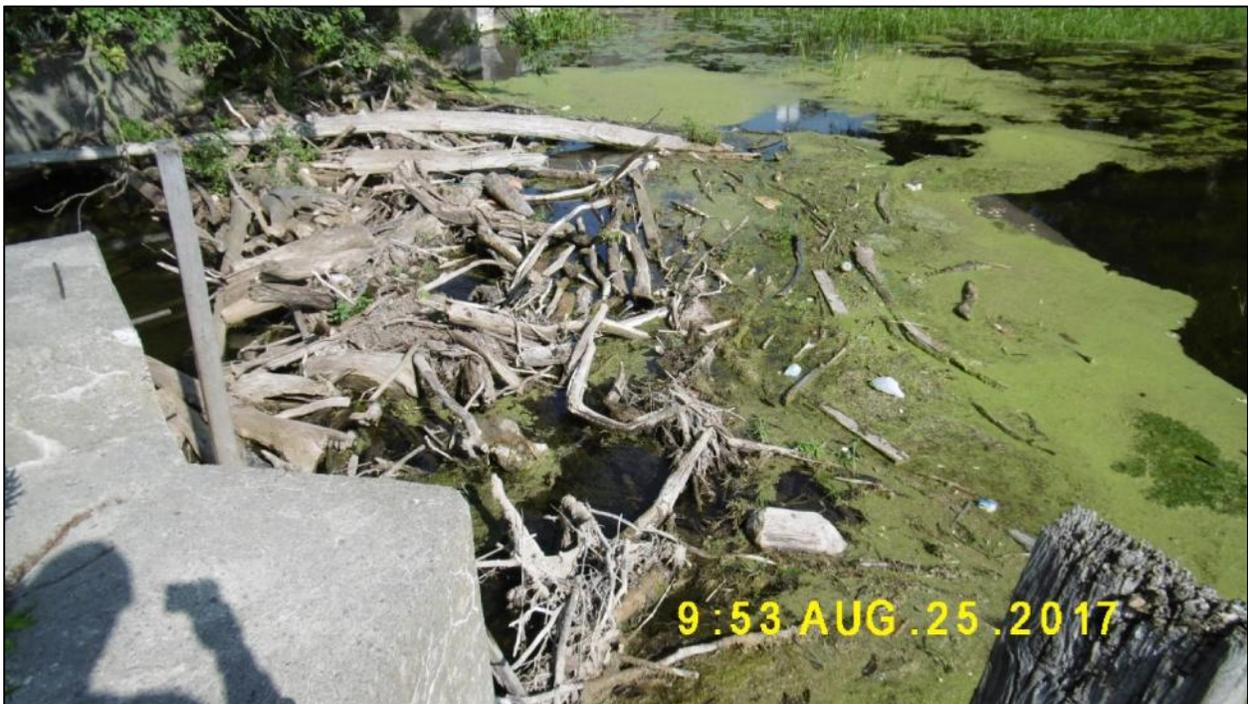
*Photo 14 – Vegetation on or near South Stop Log Structure*

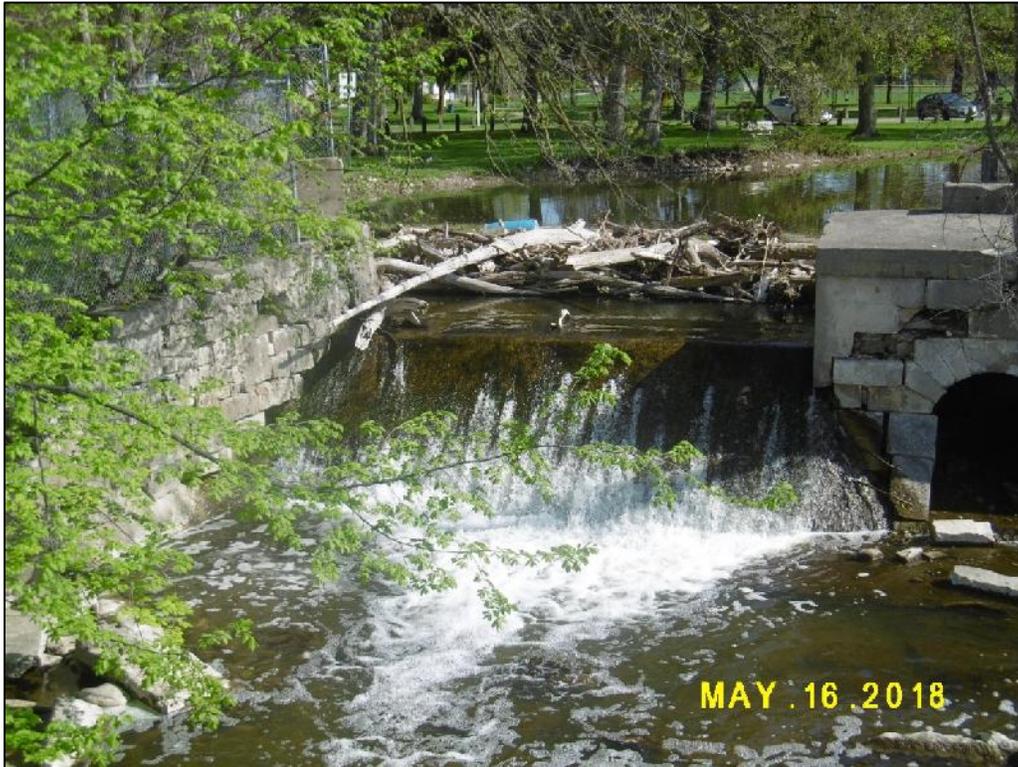
Erosion along the face of the spillway was observed. Within the white-water zones, the depth of concrete shell erosion typically ranged from 50 mm to a maximum of 100 mm (adjacent to the south stop log structure). Areas at bottom of the dam wall and sections of the concrete apron nearest the wall (toe of the dam) have eroded, to a maximum depth of 150mm. The underwater investigation in July 2018 found that the downstream face of the apron was in fair condition with light to medium scaling.

*Photo 21 – North Spillway – Note Erosion and Debris Blockage*
