**82 and 88 Beverly Street
Cambridge Ontario**

ARBORIST REPORT

Submission:
Zoning By-law Amendment

May 26th, 2023

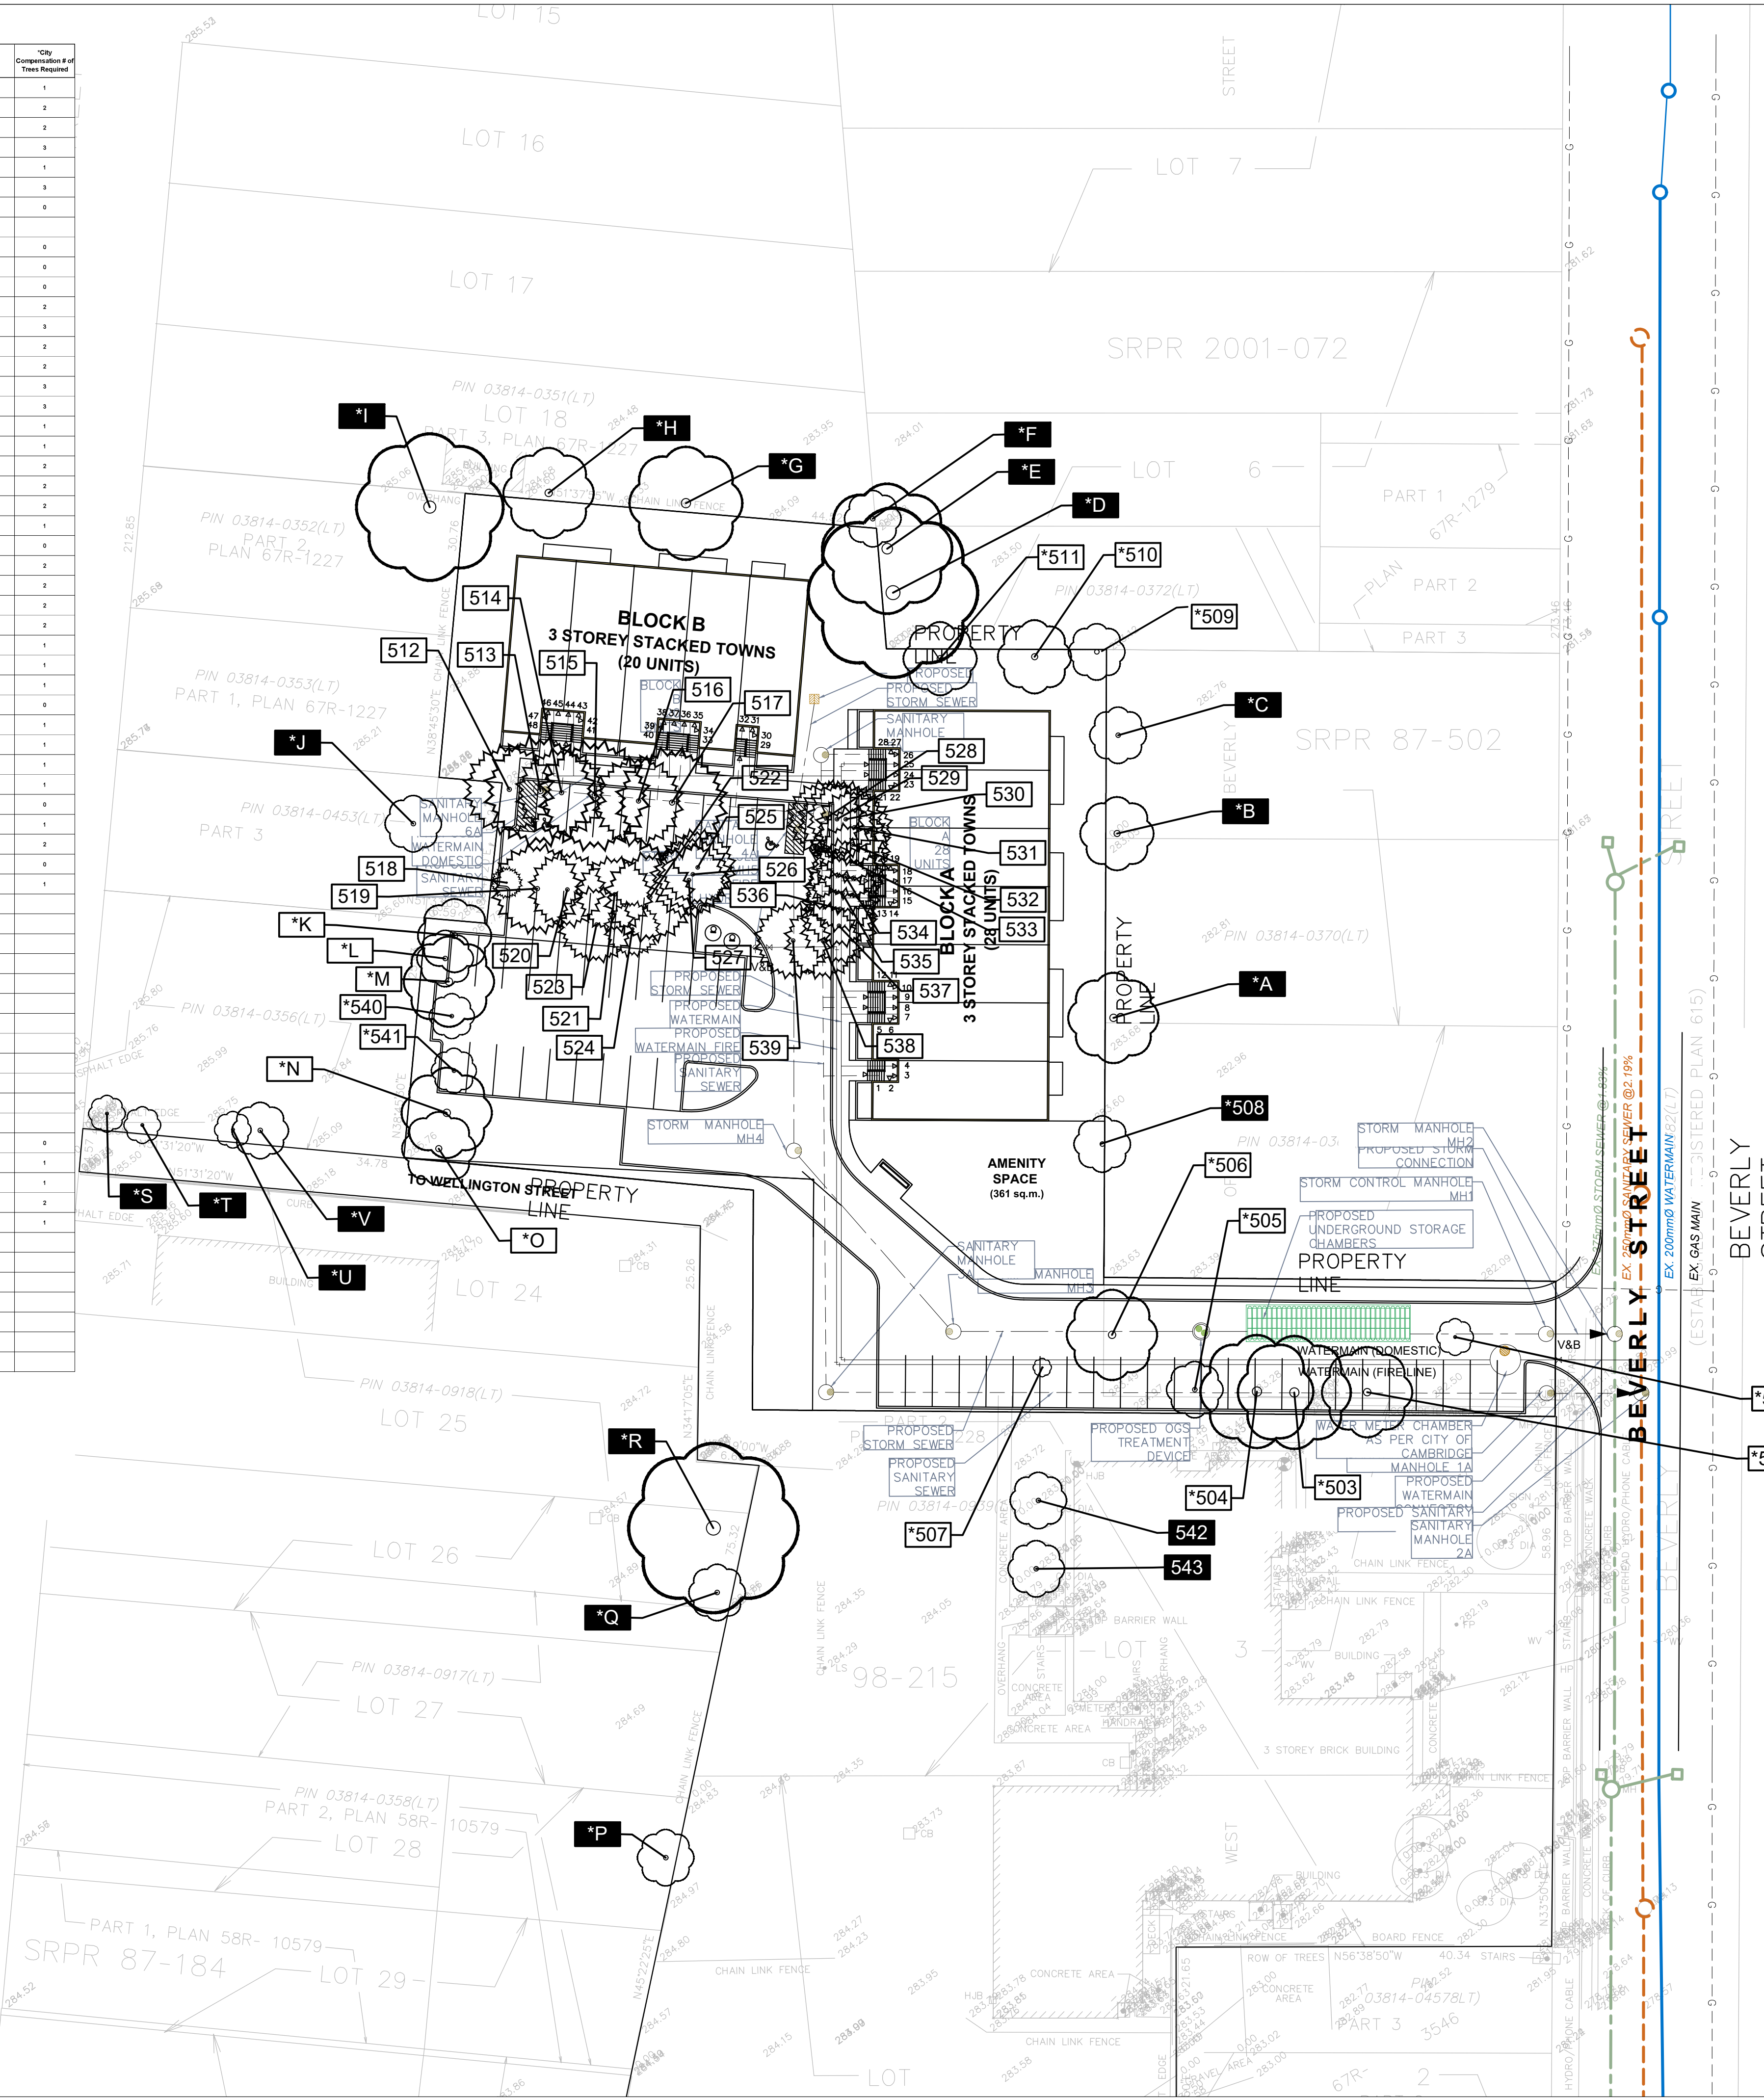
DVP-1

Upon review of the proposed layout design of the Site Plan, and understanding proposed construction related to that design, it has been recommended that forty-five, (45), trees will be removed, five, (5), will be retained and pruned, and fifteen, (15), will be retained.

It is recommended that a setback from boundary or trees owned by adjacent property owners be implemented during the detailed design stage to mitigate impacts to these trees. A setback where no excavation would occur would mitigate impacts to roots of trees #508, and 'A' through 'H'. Impacts, which could result in the removal, to trees owned by adjacent property owners require their written approval prior to impact, as such to avoid this implementing a setback is recommended. Tree #509 is considered a boundary tree as the trunk is located on the property line; however, the remaining part of the tree extends out from the existing fence and into the Project property. This tree was observed to be in poor condition and is believed it will need to be removed to facilitate construction, as such property owner approval would be required.

Tree Protection Fence (TPF) is typically installed at the limit of the dripline for trees recommended to be retained. TPF locations are identified to be installed at the limit of grading and construction. Since the limit of impact has not yet been identified, TPF will be identified on the DVMP drawings for the Site Plan Application. During the detailed design stage, it is recommended that when developing engineering plans, trees identified to be retained are recognized and best efforts are made to keep construction outside of the drip lines of these trees.
