West Existing Conditions & Analysis

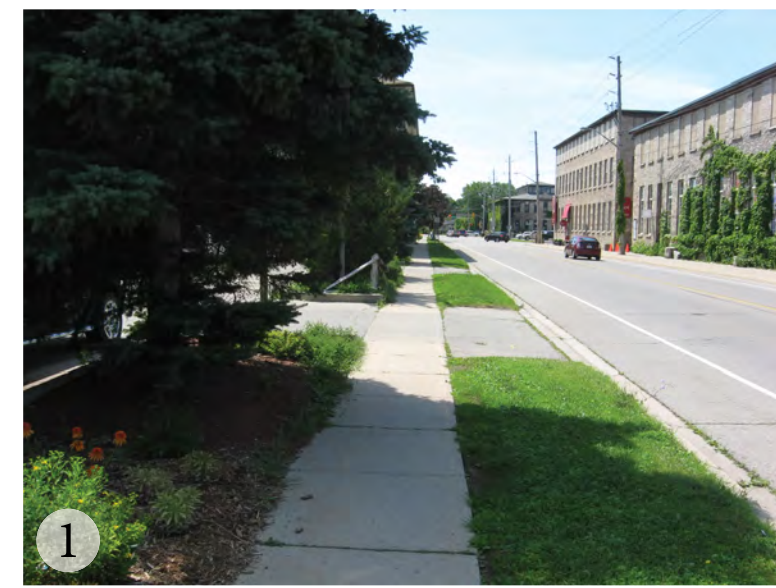
1 Sidewalk along Grand Avenue (view south) - Narrow and lacks sense of entrance to walkway/proposed pedestrian bridge

- Provides a direct and accessible route to the proposed pedestrian bridge.
- Walkway is overgrown with plant material, poor sight lines.
- Entrance and walkway are narrow and uninviting.

- Widen existing walkway surfacing and create strong entrance to invite users into the space.
- Introduce lower growing plant material 1.0m back from edges walkway to improve sight lines.

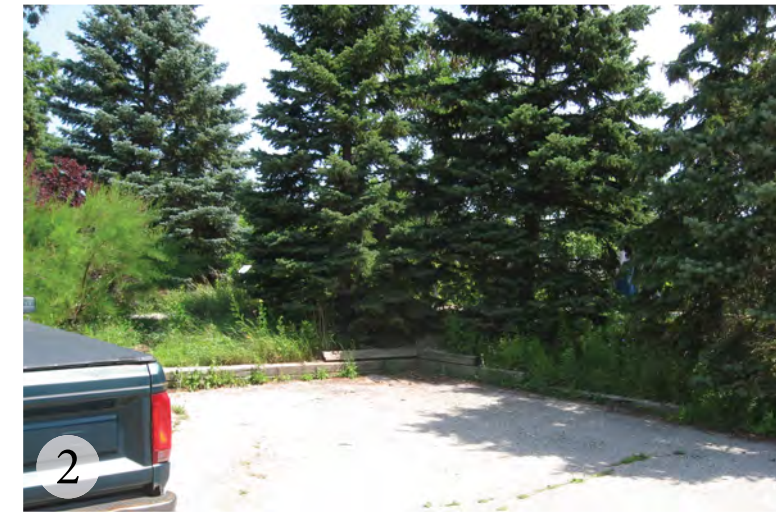
2 View from adjacent private property parking lot. Potential staging area for bridge crane during construction. Viewing area/pathway will need to expand to abut parking area, note grade differences and trees.

- Proposed abutment must extend into lookout area.
- Proposed elevation of bridge landing will be approximately 50cm higher than existing grades.

- Adjust to shape of the lookout area and location of the handrail to block area under bridge from entry.
- Expand walkway alignment toward existing parking area to ensure 3.0m minimum clearance. Safety barrier of seating stones or railing to be placed between walkway and parking to mitigate grade differences.
- Raise grades of lookout area to meet bridge grade and slope pathways as required to meet existing grades. Longitudinal slope of pathways to be 1-4% to avoid need for additional handrails (ramp).
- Consider providing access pathway from lookout node to sculpture garden.

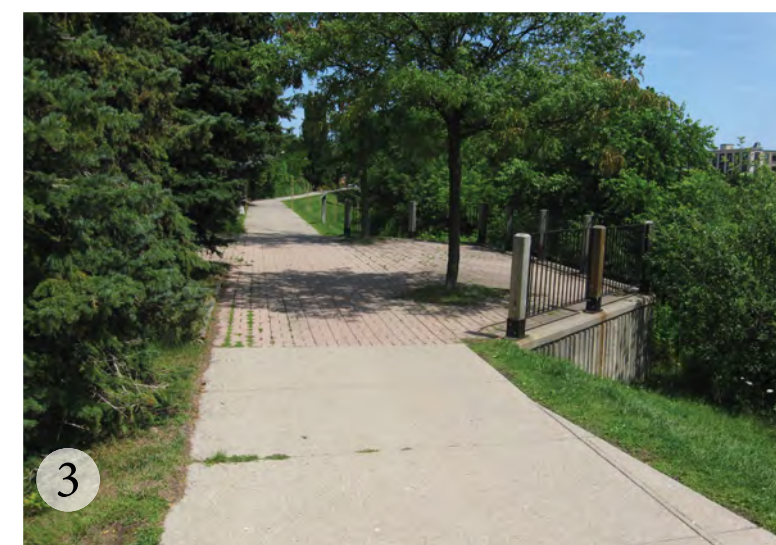
3 River walkway view approaching lookout area.

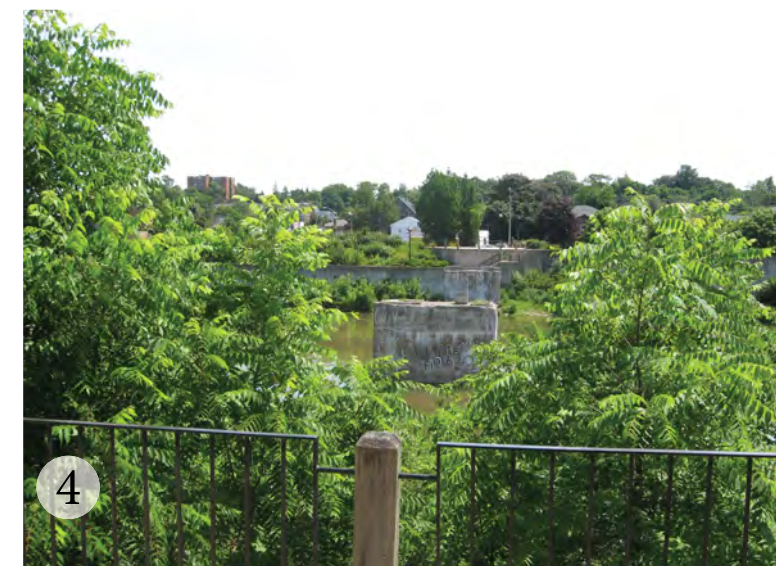
4 Lookout area - View of proposed river crossing.

- Positioned to provide views across river however area is overgrown with vegetation.
- Concrete paver surface is uneven
- Existing handrail is rusting and wooden posts are becoming split and cracked.
- Existing lighting is outdated and does not provide sufficient light.

- Ensure all surfacing smooth and continuous with no trip hazards to meet AODA standards
- Introduce new railing and update lighting.

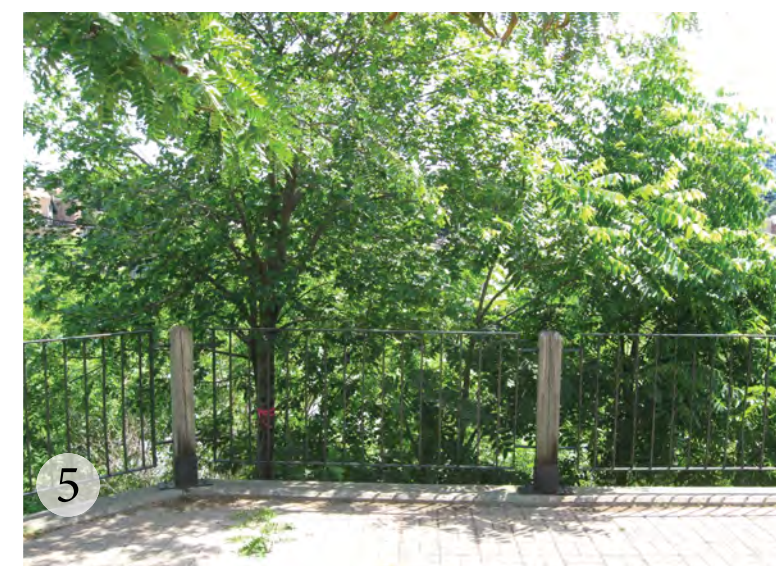
5 Lookout area - Views to river blocked by vegetation.

- Vegetation around lookout is mostly young non-native (Black Locust, Norway Maple) native invasive (Manitoba Maple), and a few (Black walnut, various shrub species) all in fair to good condition

- Vegetation to be selectively removed / pruned to allow installation of proposed pedestrian bridge and improve sight lines.

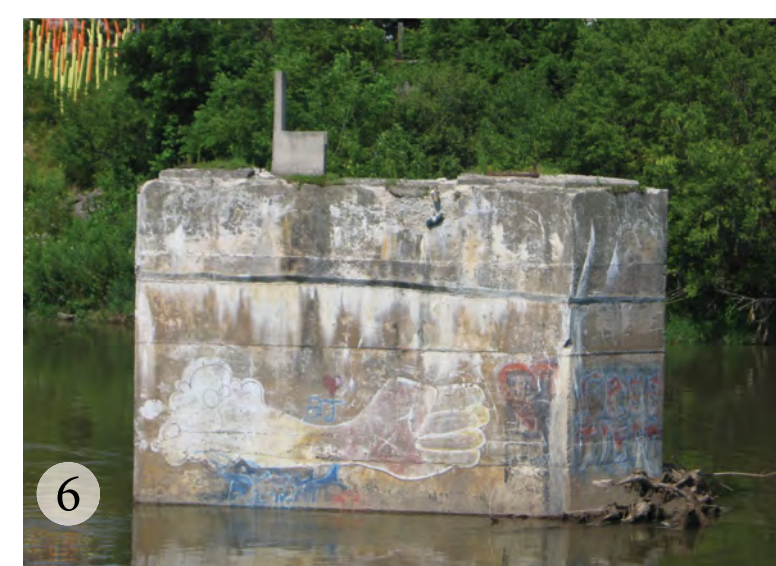
6 Existing bridge pier in river.

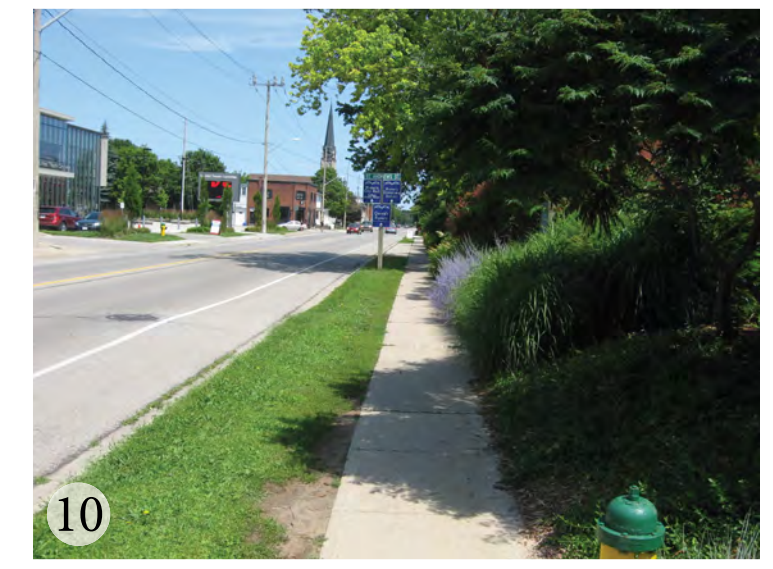
10 Sidewalk along Grand Avenue (view north) - Overgrown and narrow, lacks sense of entrance to walkway

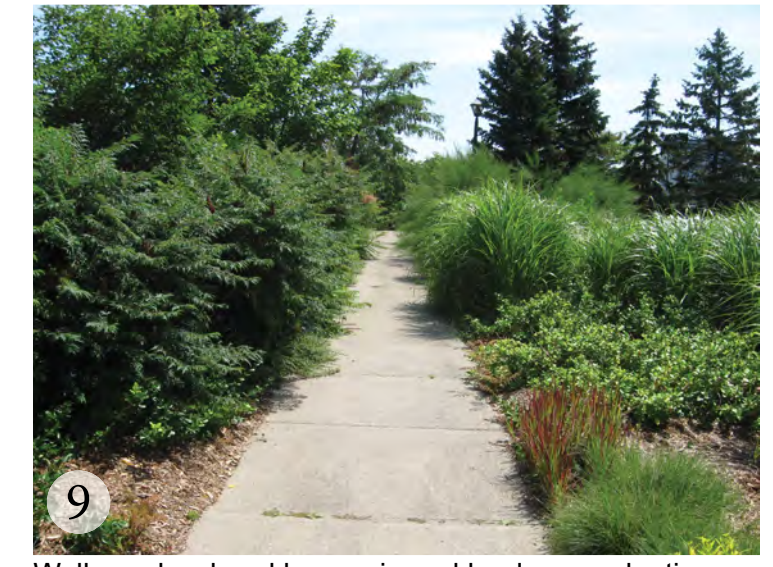
9 Walkway bordered by manicured landscape plantings. Plants are encroaching on walkway, narrowing access and visibility.

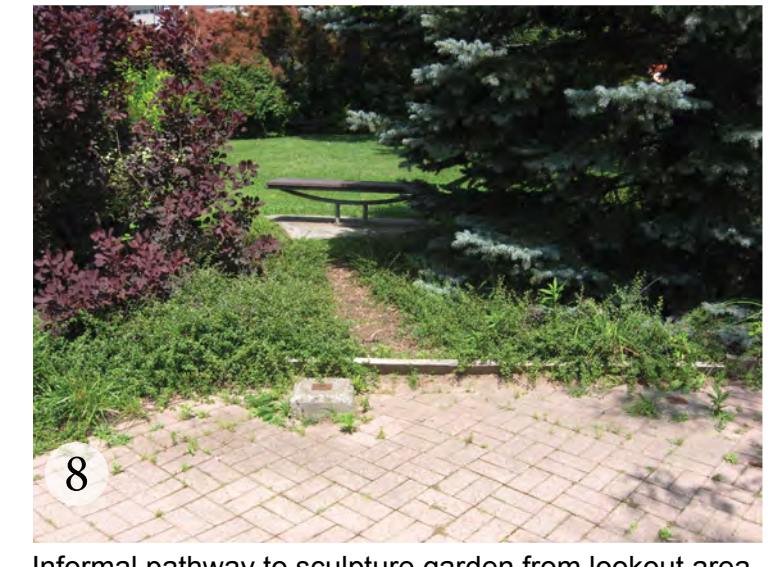
8 Informal pathway to sculpture garden from lookout area.

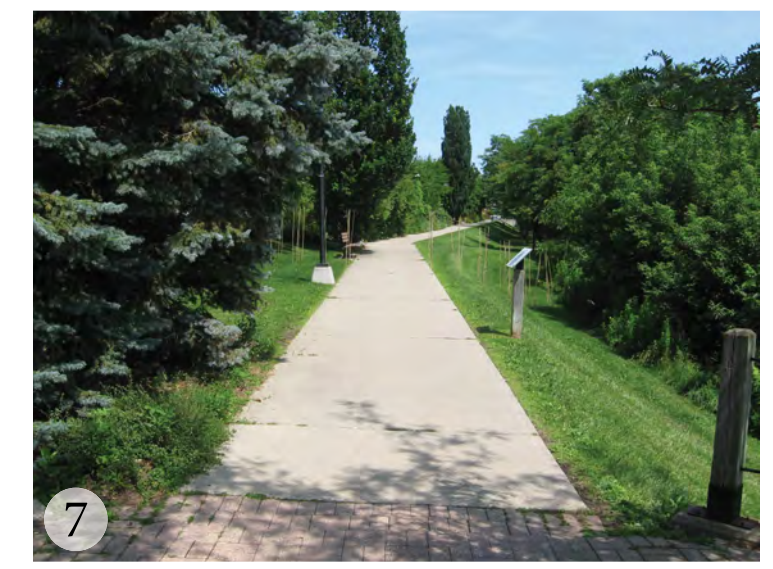
7 Looking north of the lookout area. Location of interpretive sign, bench and temporary public art installation.

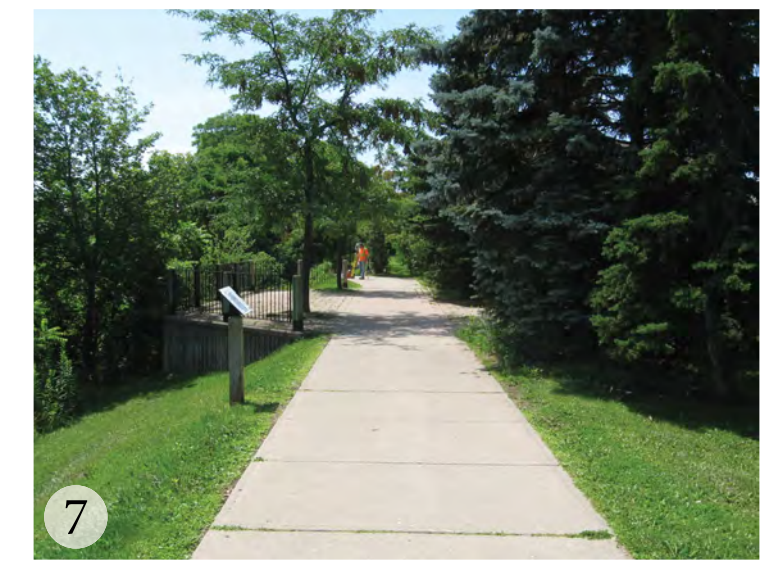
7 North of lookout area (looking south). Location of interpretive sign, bench and temporary public art installation.
