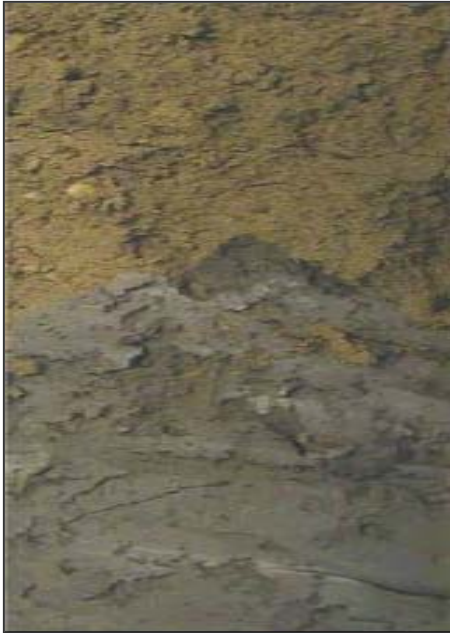
**Photograph B1 – Port Stanley Till overlying Maryhill Till in a soil sample from BH2**

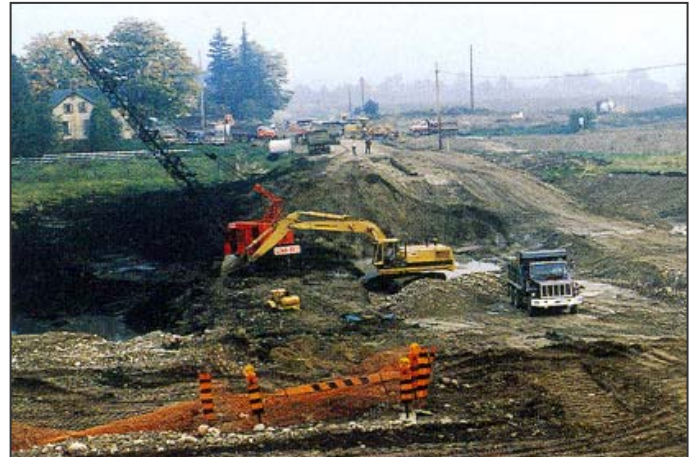
**Photograph B2 - Excavation of a peat bog near the intersection of Fountain Street and Maple Grove Road.**

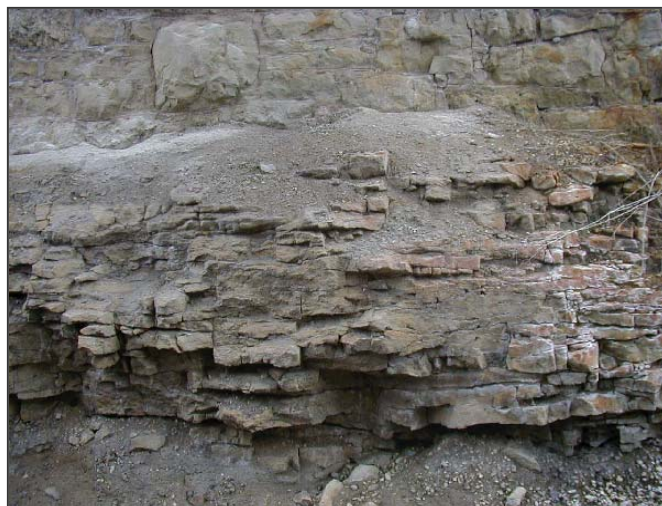
**Photograph B3 - Guelph Formation dolostone exposed in the Speed River valley to the east of the study area.**

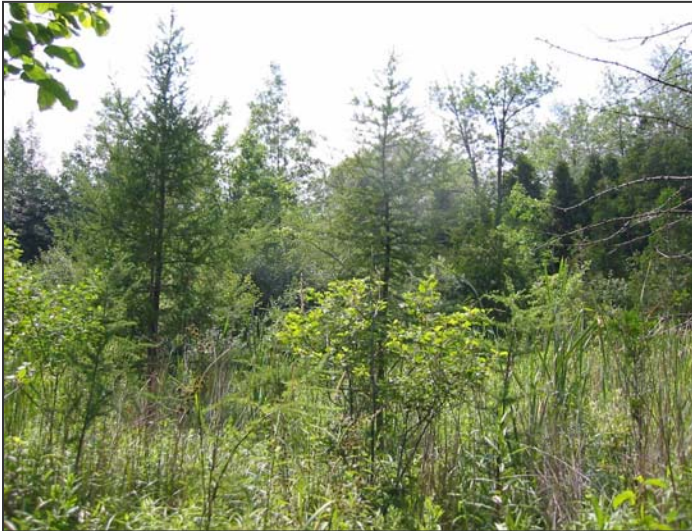
**Photograph B12 - Vegetation unit 6.30b: Organic meadow marsh on deep organic soils, in the lower end of the Middle Creek Subwatershed. This is associated with a forested wetland where significant groundwater discharge was observed.**

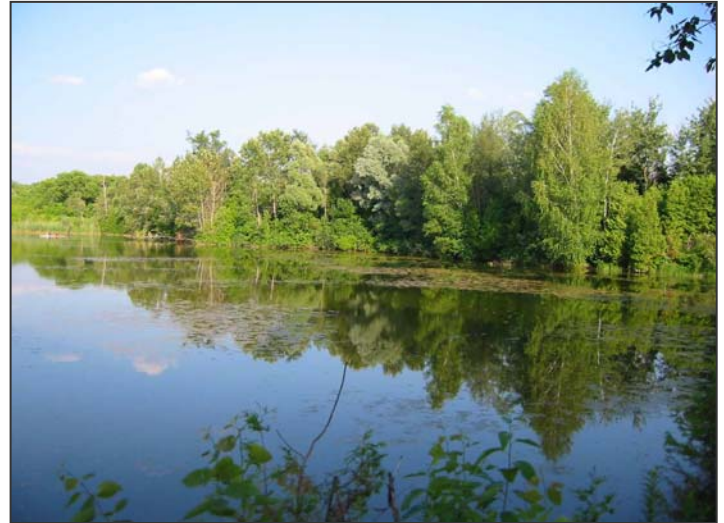
**Photograph B13 - Vegetation unit 5.13a: This dug pond, fed by groundwater, is part of a former sand and gravel pit located in the West Creek Subwatershed. This is the largest open water feature in the three subwatersheds.**
