West Existing Conditions & Analysis

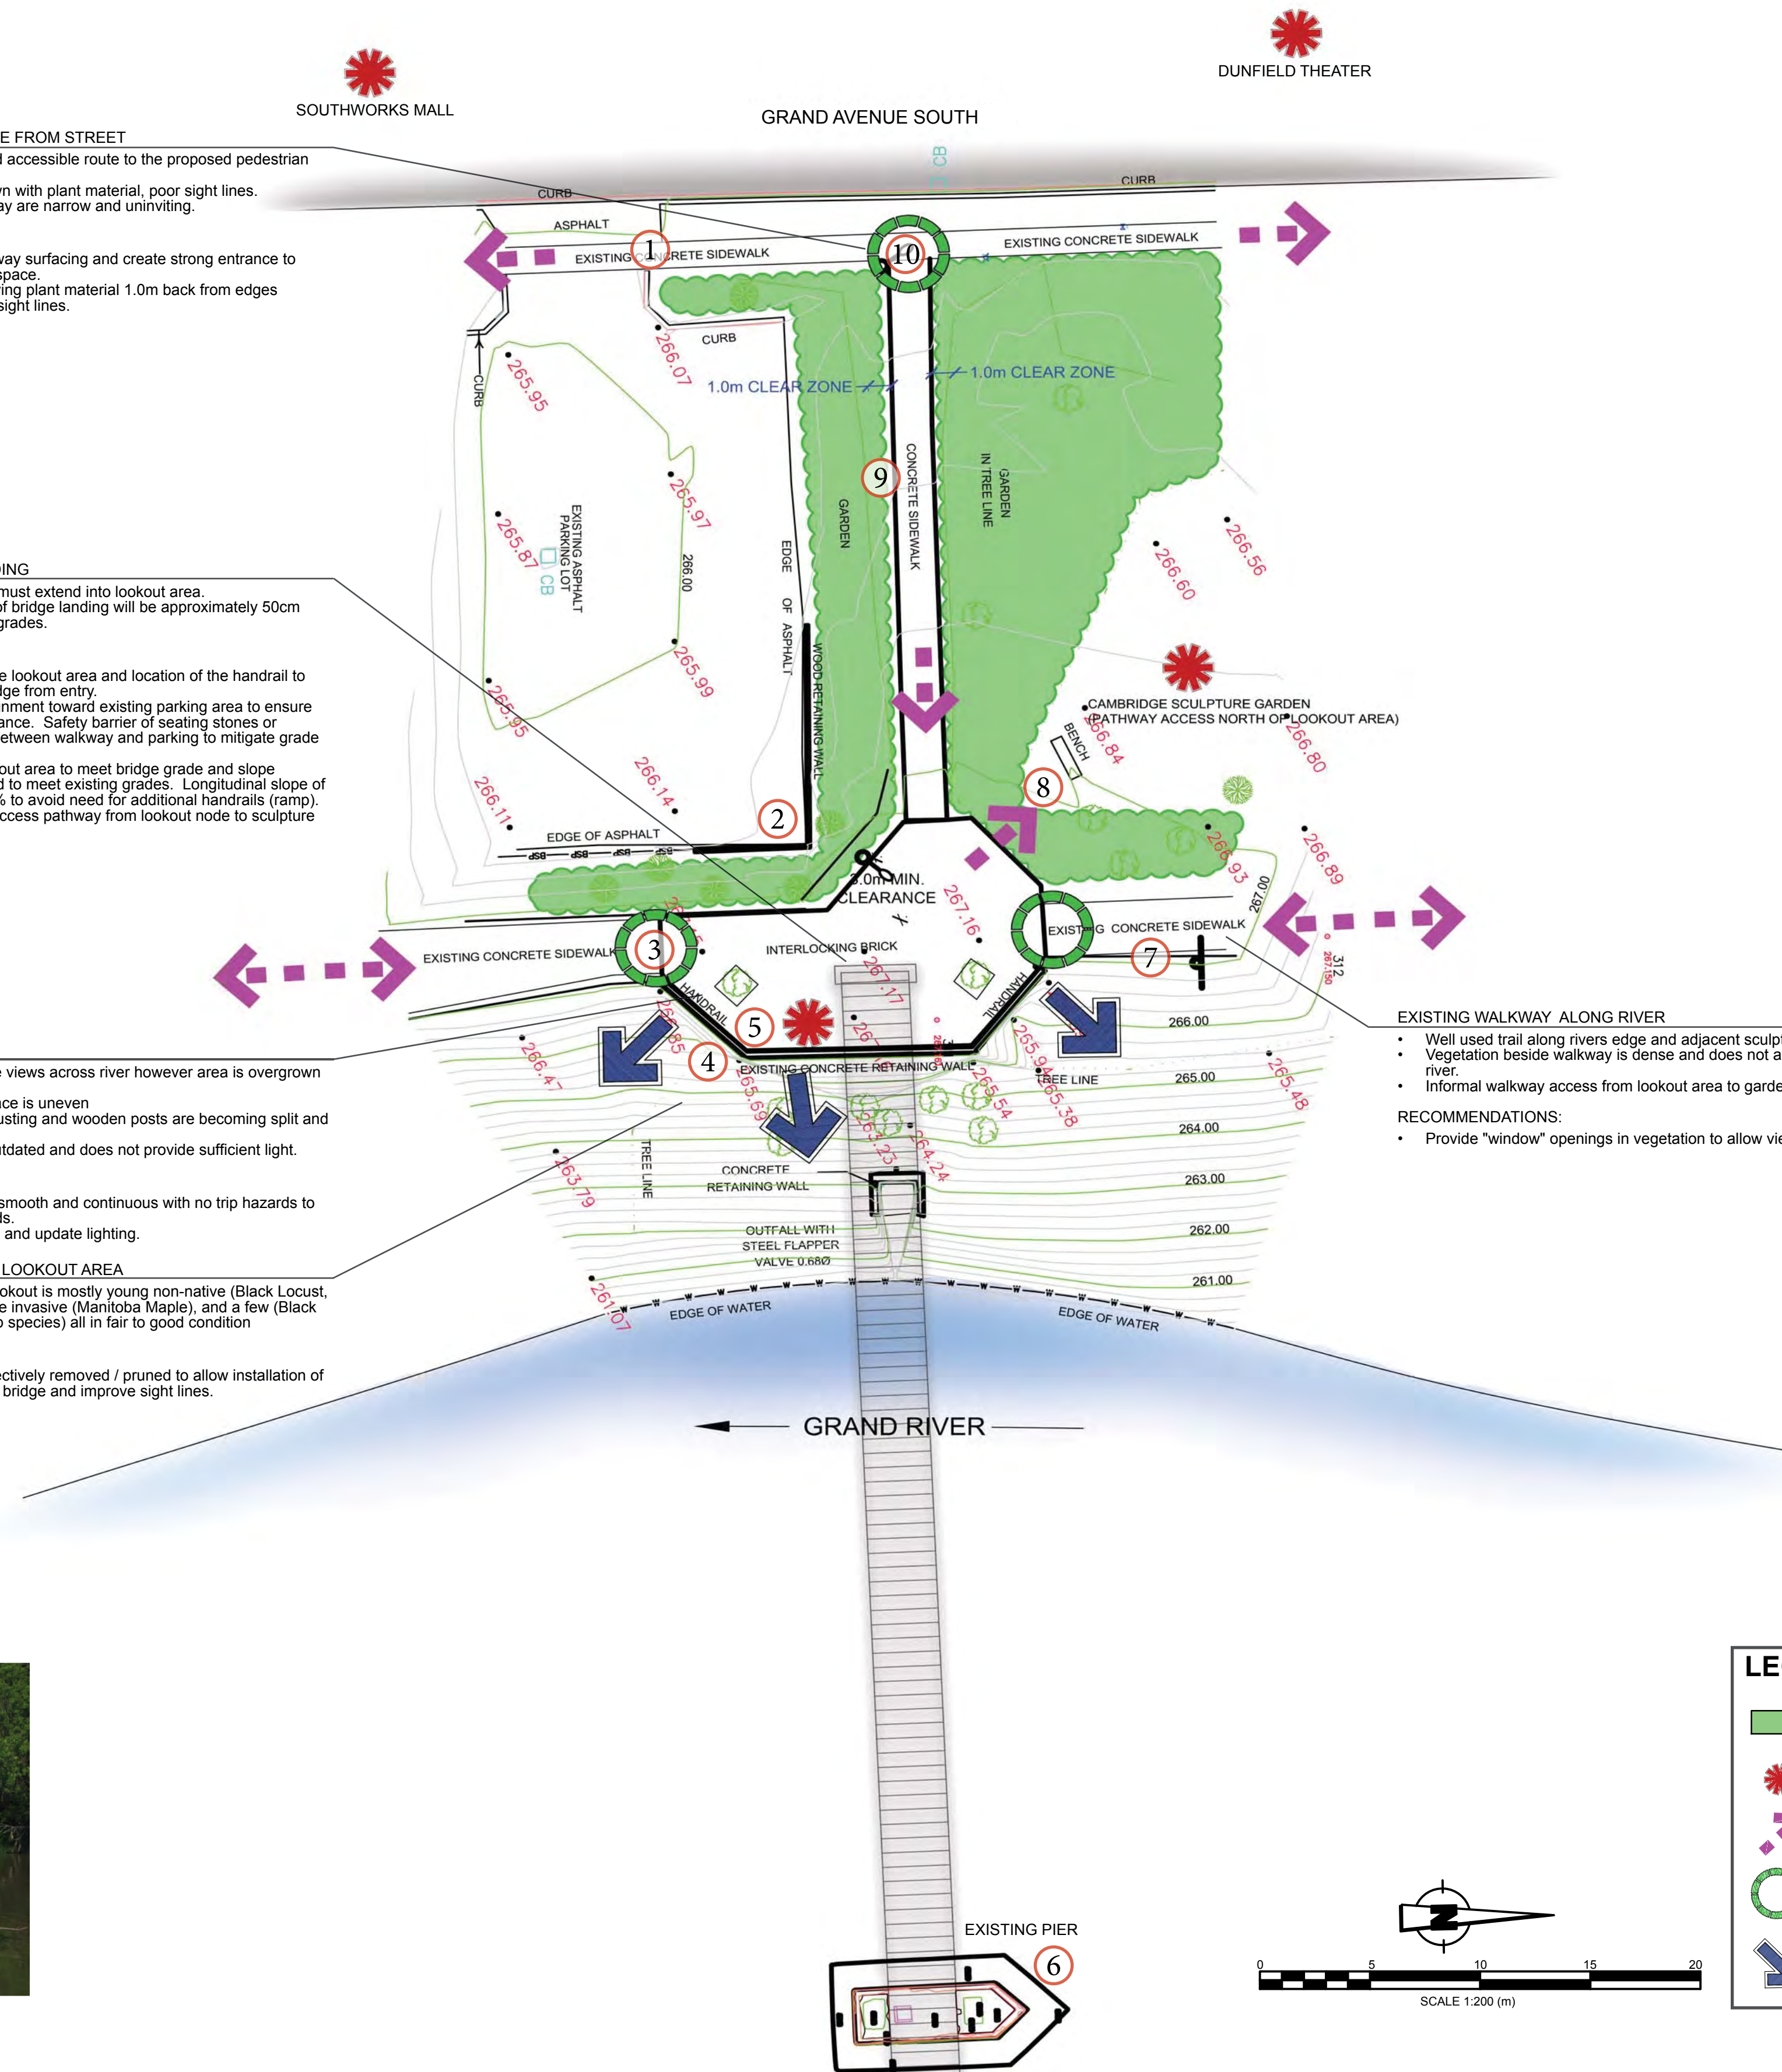
- Provides a direct and accessible route to the proposed pedestrian bridge.
- Walkway is overgrown with plant material, poor sight lines.
- Entrance and walkway are narrow and uninviting.

- Proposed abutment must extend into lookout area.
- Proposed elevation of bridge landing will be approximately 50cm higher than existing grades.

- Positioned to provide views across river however area is overgrown with vegetation.
- Concrete paver surface is uneven
- Existing handrail is rusting and wooden posts are becoming split and cracked.
- Existing lighting is outdated and does not provide sufficient light.

- Vegetation around lookout is mostly young non-native (Black Locust, Norway Maple) native invasive (Manitoba Maple), and a few (Black walnut, various shrub species) all in fair to good condition

- Widen existing walkway surfacing and create strong entrance to invite users into the space.
- Introduce lower growing plant material 1.0m back from edges walkway to improve sight lines.

- Ensure all surfacing smooth and continuous with no trip hazards to meet AODA standards
- Introduce new railing and update lighting.

- Vegetation to be selectively removed / pruned to allow installation of proposed pedestrian bridge and improve sight lines.
